**APPLICATION OF THE 8D  
METHODOLOGY TO REDUCE  
FAILURES IN THE DUST  
FILTRATION SYSTEM IN THE  
CEMENT INDUSTRY**

## **Application of the 8D Methodology to Reduce Failures in the Dust Filtration System in the Cement Industry**

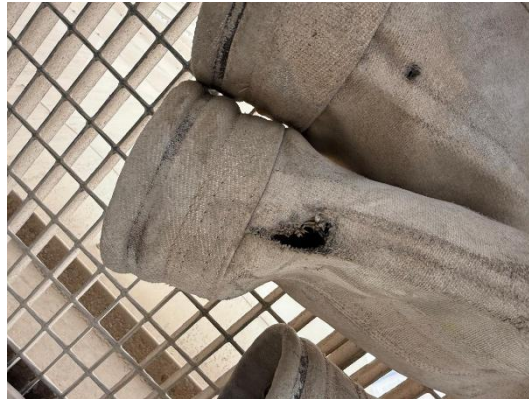
**Figure 1.** Breakage of upper part 1.

Inspections of the various compartments reveal that the primary bag failure occurs in the upper section, as shown in Figure 1.

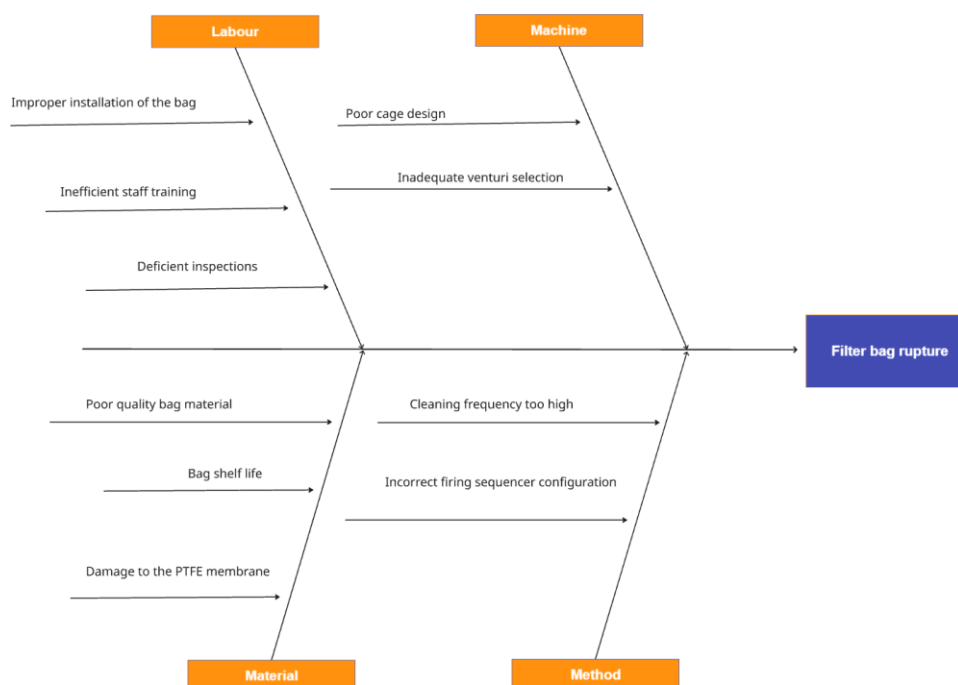
**Figure 2.** Ishikawa diagram for the analysis of causes of filter bag failure

**Labor:** It was found that the filter bags in the filtration system were improperly installed due to inadequate staff training; furthermore, the inspections being conducted were deficient.

**Machine:** The cages installed in the filtration system are poorly designed, as they lack a venturi to accelerate fluid flow; consequently, the air does not move at the proper speed to traverse the entire bag. This results in uneven cleaning, as the bag is too large. Additionally, the connection between the collar and the cage's vertical ribs is exposed and in direct contact with the bag, causing weld defects to tear the bag at the top, as shown in Figure 3.

**Material:** A bag was sampled for laboratory analysis, yielding the following results. Microscope images reveal the deterioration of the PTFE membrane and dust accumulation within the fabric structure, leading to saturation, as shown in Figure 4.

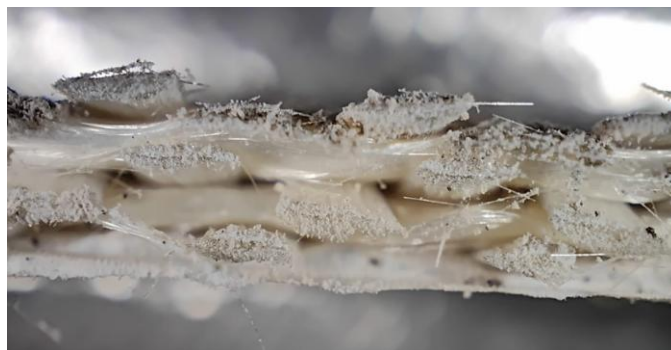
**Figure 8.** Dust penetration

As shown in Table 5, the mass per unit area indicates significant particle accumulation and dust impregnation within the fiber structure as can be seen in Figure 5 since the cleaning process failed to restore the nominal value. Regarding air permeability, the results fall within the reference range; however, these values are very low compared to the quality of other filter fibers. Permeability doubles after cleaning; this fact, combined with the visual inspection, confirms the observed deterioration of the membrane.
